NSWCCD-65-TR-2003/37 September 2003

SIDER Testing of Royal Navy Vessel P292 HMS *Trumpeter*

This report presents the results of a single Structural Irregularity and Damage Evaluation Routine (SIDER) inspection of the forecastle of HMS *Trumpeter*, pennant number P292. HMS *Trumpeter* is a Royal Navy *Archer*-Class fast patrol craft that was, until recently, in service off Gibraltar. The class has a displacement of 88,000 lbs (40 tonnes), is 65-feet 6-inches (twenty meters) long and has a breadth of 19-feet (5.8 meters). The craft have a complement of ten and are unarmed, except in wartime when they are fitted with a 20mm close-range gun. Their maximum speed is 25 knots, being propelled by twin Rolls Royce Eagle Engines - the same type used by the British Army's Chieftain tank.

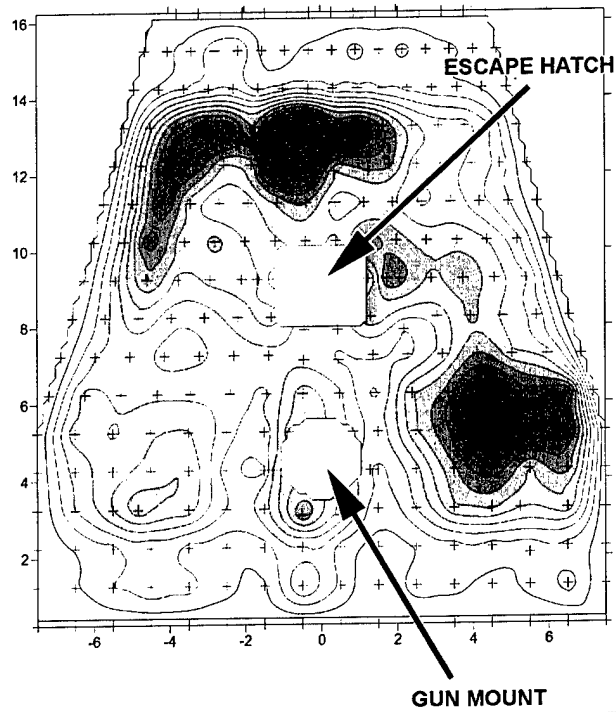
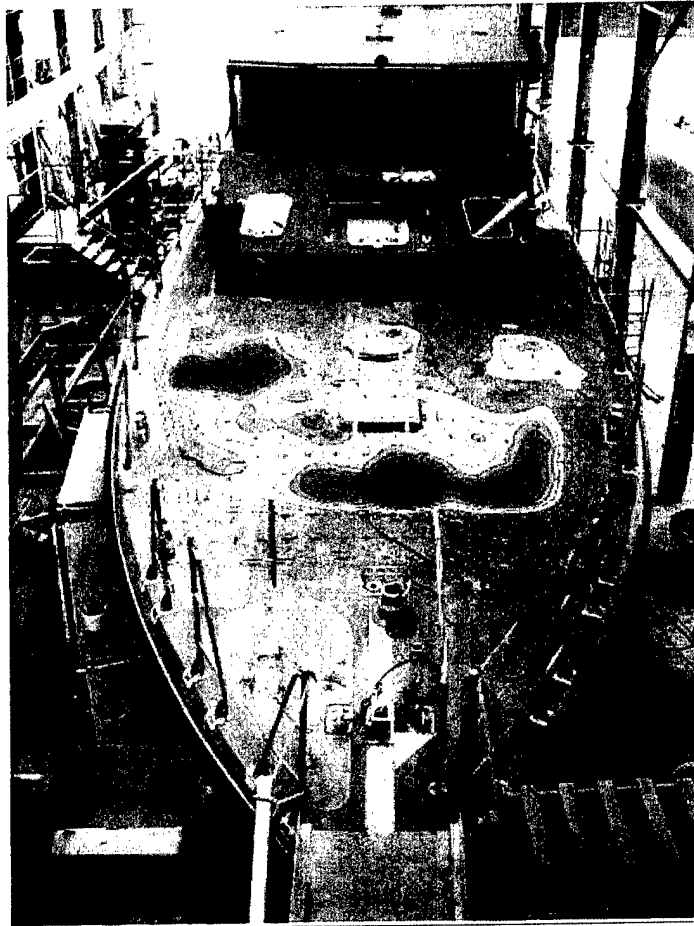
Figure 7. SIDER Fore-Aft Analysis

Figure 7 and Figure 8 show the SIDER contour plots. On these plots the small crosses show the test grid and the axes legends show the distance in feet from the global origin. The SIDER is a directional test. Thus there are two results, one for the fore/aft analysis and one for the port/starboard analysis. Each result is shown as a contour plot, and separately overlayed on a photograph of the foredeck. Note that the contour plots can be used to accurately locate features, whereas the foreshortening of the photographs means that features can be shown up to a foot or more from their actual position on the photographs.

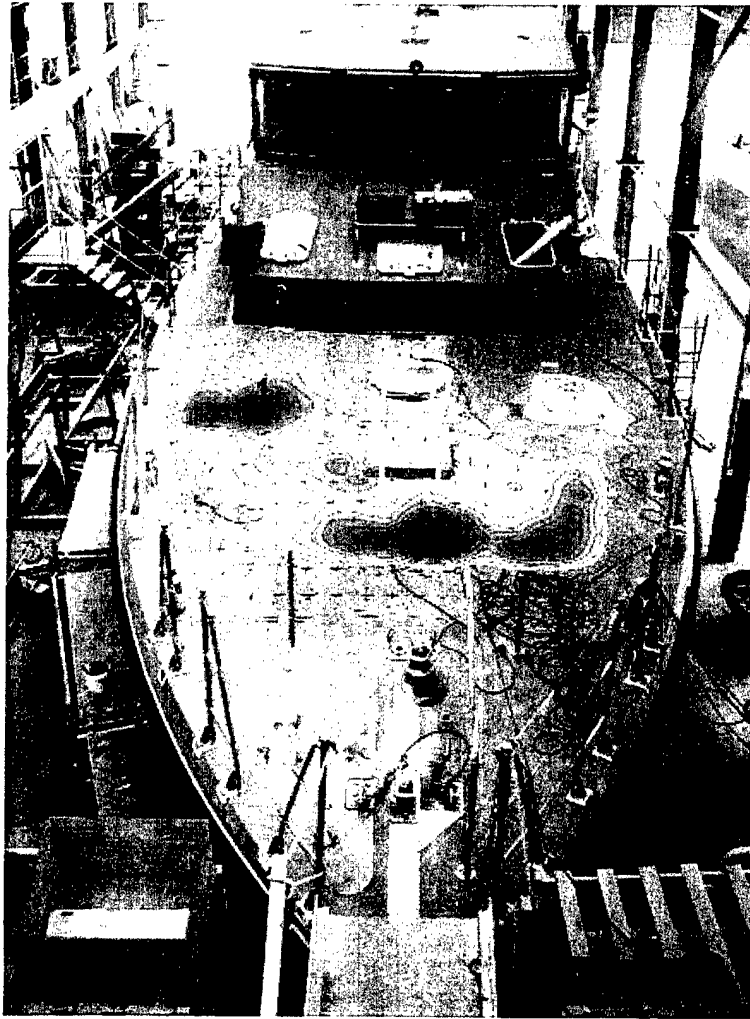
Figure 9. Fore-Aft Analysis with Identified Features

Figure 9 repeats Figure 7, but with two features highlighted. Feature 1 is coincident with a structural bulkhead that runs from the starboard side to the gun mount. The bulkhead does not continue to the port side. SIDER has located the stiffness change caused by this bulkhead.

Feature 2 has a maximum at the marked position, but it also extends along a port-starboard line. Just forward of this feature is a significant structural bulkhead that is almost coincident with the forward edge of the test mesh. SIDER has located the stiffness change (reduction) caused by the transition from the stiff area to the main foredeck.

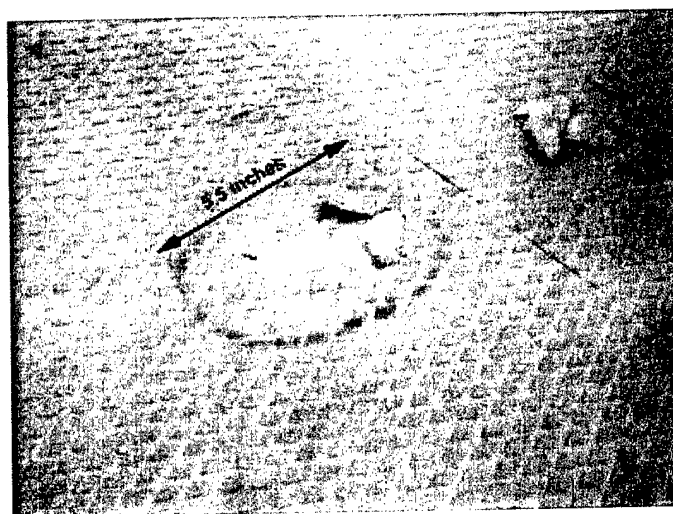
Feature 6 is a major non-symmetric feature. This feature maps exactly to the lack of bulkhead mentioned in the fore-aft analysis (feature 1). Feature 1 is also coincident with a section where the nonskid surface was not bonded to the substrate, as shown in Figure 11. It is surprising to the authors that SIDER was able to locate this type of problem. The technique typically identifies regions where there are stiffness variations. The reduction in stiffness that the debonded nonskid would result in is assumed to be less than the sensitivity of the detection technique. Physical manipulation of the area, however, did reveal the soft spot that corresponded to the debonded region.

Figure 11. Damage to Nonskid Surface
